# Knowle Hall Revisited

An Investigation by Solihull Archaeological Group

May – September 2011

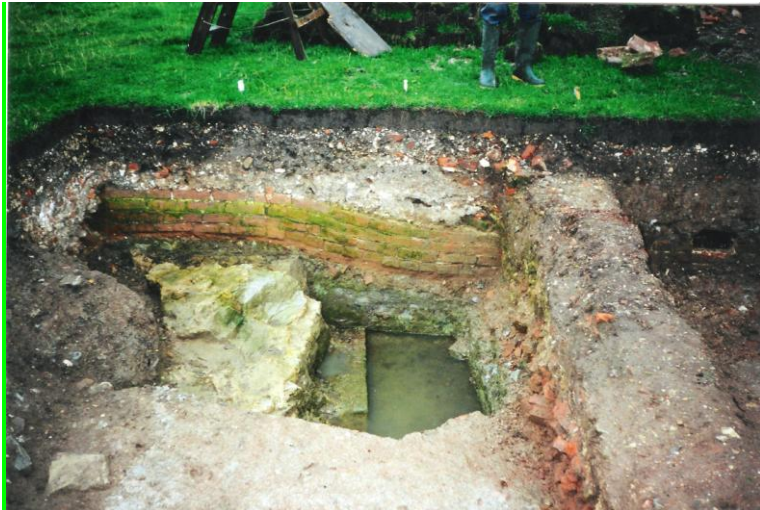
**Photo 1: Excavation in 2000 - area of interest**

Dr Smith determined there had been five phases and that the earliest phase was represented by a moated site. The earlier remains lay in water-logged conditions (which had helped preserve the early timber moat revetment, dated by dendrochronology to the early 13<sup>th</sup> century) and the previous owner of the site confirmed that the water table in the area fluctuates significantly. Late in the last (2000) season of excavation a stone mass was found in the southwest corner of the site standing on top of some high quality ashlar blocks. The blocks were mostly covered but it did appear that they and the stone mass were on slightly different alignments (photo 1).

These particular features were not ascribed to any particular phase in the reports and may have represented two separate phases of construction. Significantly however it was concluded that the stone mass lay just outside the inner edge of the earlier moat in its southeast corner. Our 2011 excavation set out to rediscover these features and to seek to understand how they related to the rest of the site.

The north-south brick drain had subsided south of the stone mass. This is most clearly seen in photo 1. It was deduced therefore that the drain post-dated the stone mass rather than being contemporary with it. Thus the drain was not a part of the drainage of the moated platform of which the stone mass was assumed to be a corner abutment. The drain continued to the north directly in line with feature shown as 762/726/708 on the Phase 4 drawing from the 2000 excavation report (figure 5).

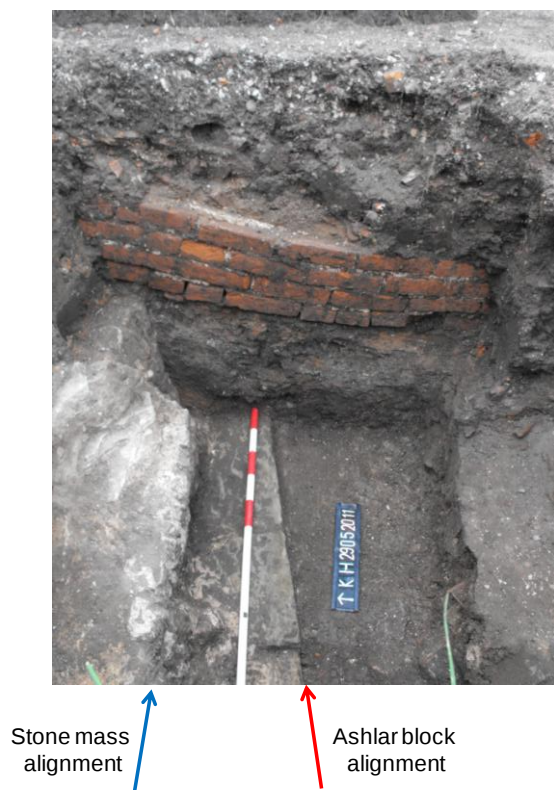
**Photo 2: 2011 'area of interest'**

The ashlar blocks were confirmed as appearing on a different alignment from the stone mass that overlay them (photo 2). This should be compared with photo 1 - note the much lower water table.

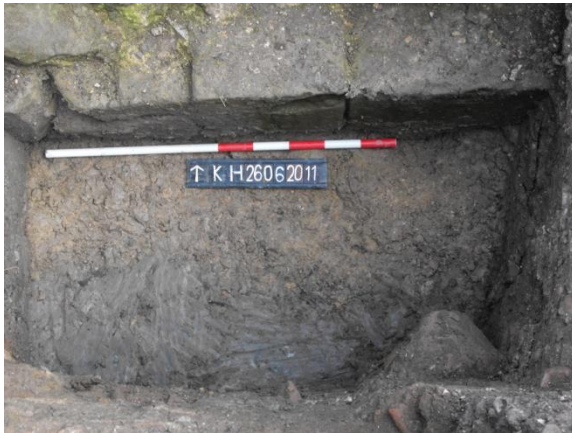
**Photo 3: 2 courses of Ashlar blocks**

The ashlar blocks were formed of two courses founded on large cobble stones (photos 3 & 4) which appeared to be laid on natural earth (the water table was encountered at this level)

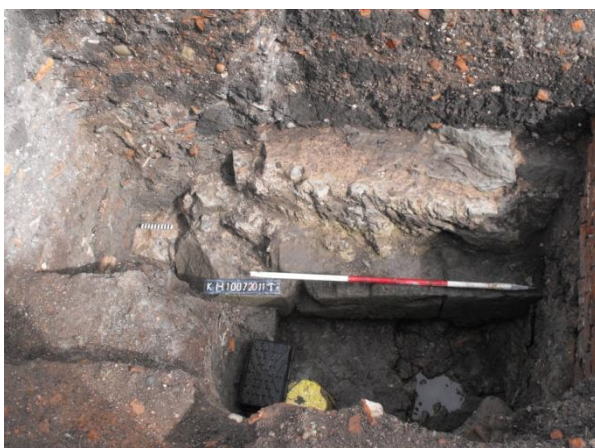
**Photo 5: West end of stone mass/ashlar feature**

The ashlar blocks were found to continue to the west and east of the north-south brick culvert (D600). Those to the west continued for approximately 1.5 metres and then a clearly chamfered edge appeared (photo 5). Excavation in a northerly direction confirmed the continuation of this feature. Extension of the trench to the west demonstrated that the ashlar feature did not continue in that direction. This point was therefore taken as the west end of the feature.

It was in this area, and level with the upper ashlar blocks, that a significant wooden plank was found (covered by the tray in the photo 5). Further details are given below.

It can be seen from photo 5 that the alignment of the stone mass is no longer so different from that of the ashlar blocks.

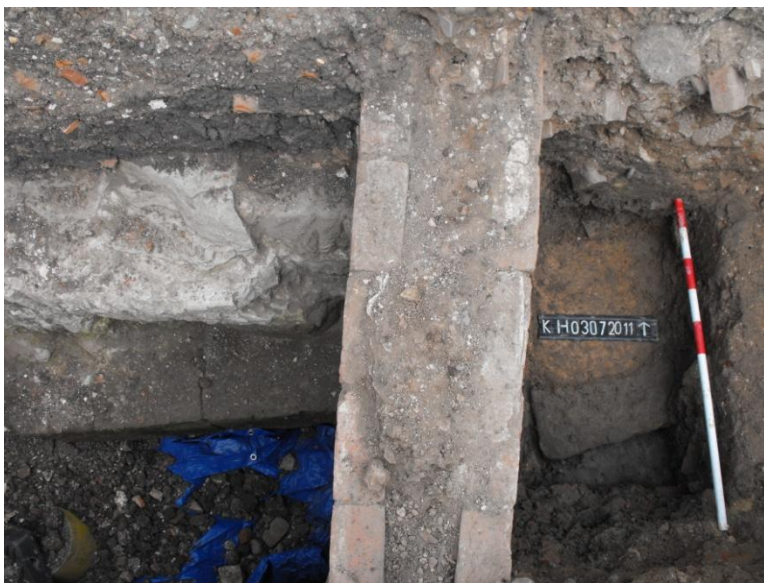
#### **Photo 6: Ashlar blocks to east of brick drain**

Excavation of the area to the east of the brick culvert established that the ashlar blocks and stone mass continued but almost immediately turned to the north, thus establishing an eastern limit to the feature (photo 6). The orange material overlying the ashlar blocks was interpreted as the mortar beneath a further block/stone mass that had been robbed out. It was also considered that the remaining lower block had become displaced from its original position.

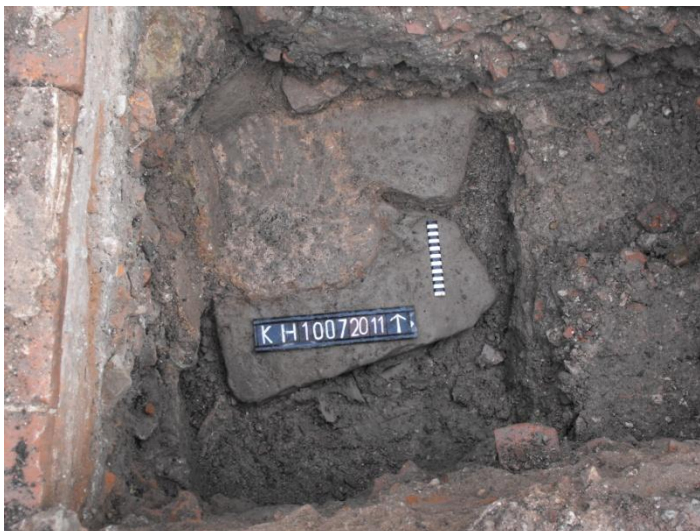
#### **Photo 7: Evidence of the corner of the feature**

The continuation northward can clearly be seen in photo 7.

This is just visible in the top left of photo 7 and lies within the boundary of the ashlar block feature. It was concluded that this area represented the east end of the abutment. This area had not been excavated in the 2000 season. The stones referred to were overlain by demolition rubble including a collection of soot-covered bricks (photo 8).

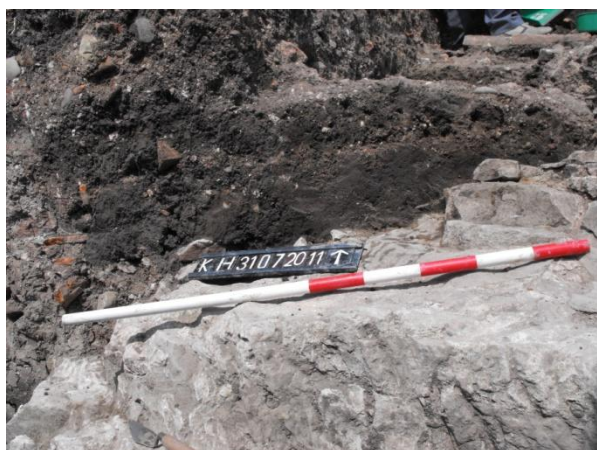
**Photo 9: Northern extent of stone mass**

Excavation was carried out to the north of the exposed stone mass to determine its extent. This was found to be bounded by very dark earth (photo 9) and, consistent with SAG's interpretation in the earlier excavations, was taken to be evidence of the location of the inner edge of the moat.

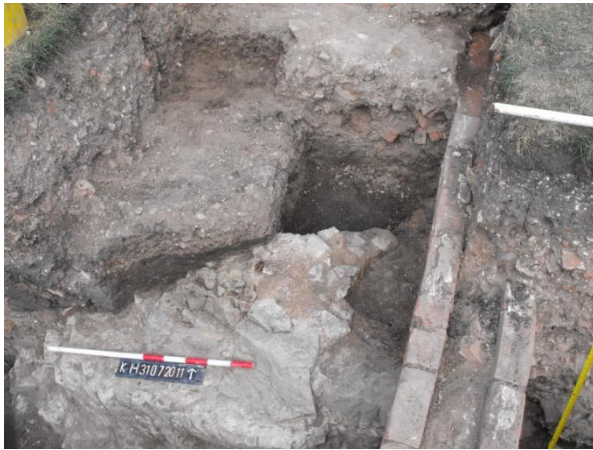
**Photo 10: Deep trench confirming extent of stone mass**

This was further confirmed by a small, but deep, excavation alongside its northern face. No ashlar blocks were found underlying the stone mass on the northern side (photo 10).

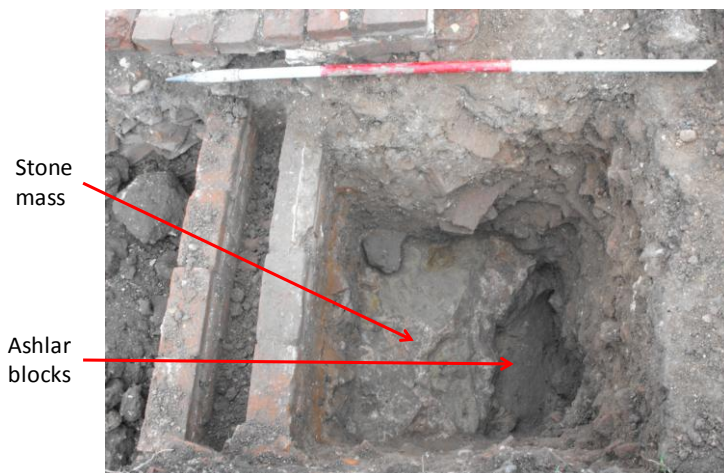
**Photo 11: Stone mass to north of excavation**

A trench was excavated to the north of this area which revealed the continuation northwards (but not further east) of the stone mass (**E402**) situated on ashlar blocks (photo 11)

Our interpretation is therefore that the stone mass, positioned on top of quality ashlar foundations on the south side was the core of an abutment with good quality stones (since robbed out) to the visible south and east sides and holding back the earth forming the moated platform. As this side was covered by earth there was no need to provide a quality appearance.

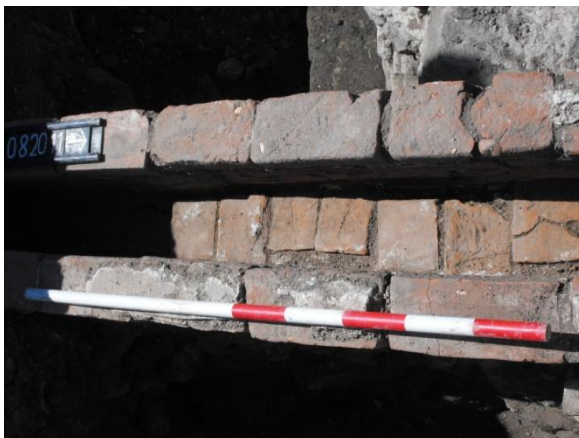
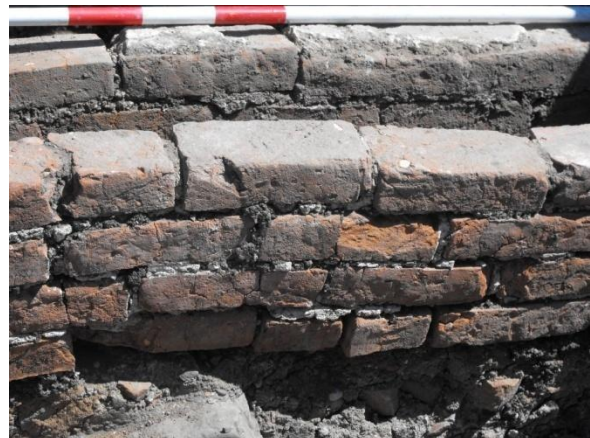
**Photo 12: Brick drain interior and exterior**

The drain was subsequently excavated (photos 11 & 12) but was entirely full of earth. No finds at all were contained within it and so the feature has not been able to be dated. The drain was formed of longitudinal bricks placed over base bricks laid perpendicularly. It was assumed a layer of tiles was placed on top but no evidence was found for these.

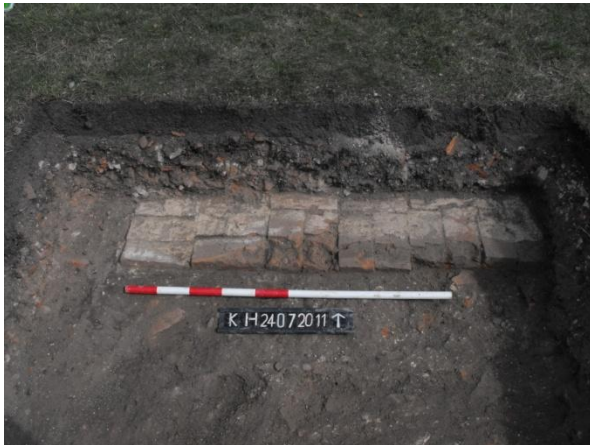
**Photo 13: East west wall at north end of excavation**

An unexpected feature was a brick wall running east west across the north end of the excavation (photo 13).

There had been no sign on this in the previous excavations, nor was there any record of a structure in this area on the Warde drawing (figure 2). Extension of the trench revealed this to be a feature of  $1\frac{1}{2}$  bricks wide and comprising only a single course of bricks. The feature turned north at the west end and continued in the same form northwards (photo 14). This photo also shows the feature clearly overlying the north-south drain indicating that it was a later feature.

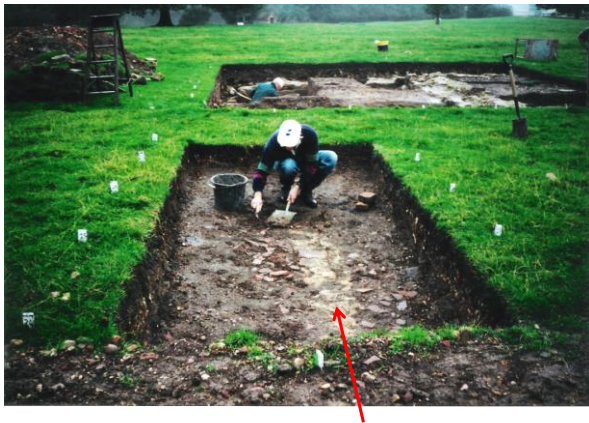
**Photo 15: 2000 excavation to north of 2011 trench (looking south)**

Reference to the 2000 season excavation indicated that this feature had been discovered slightly to the north (photo 15).

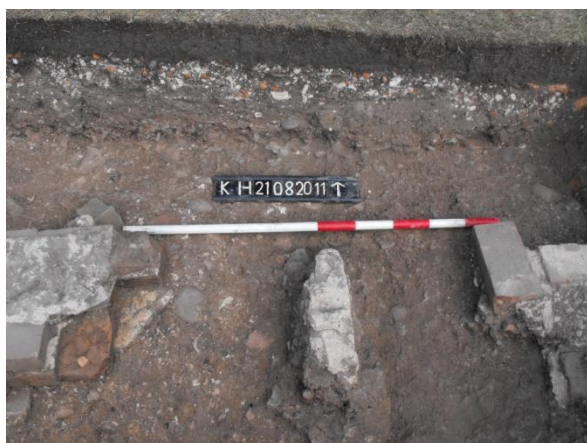
**Photo 16: Possible doorway in northern wall B101**

Further excavation of this feature was carried out to establish its eastern edge. Part way along the feature a double gap with a central concreted stone was found (photo 16).

This was interpreted as a possible doorway comprising two narrow doors such as might be found on a greenhouse or similar garden feature. The orangery at Warwick Castle is shown in photo 17 as an exemplar.

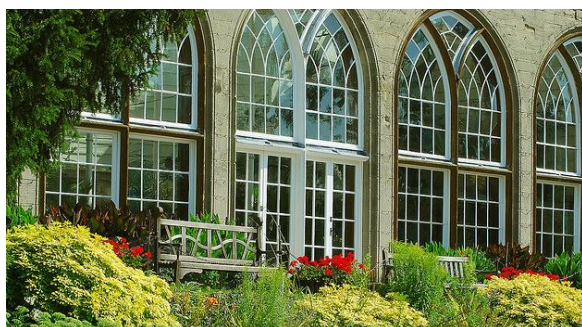
**Photo 17: Warwick Castle orangery showing doorway**

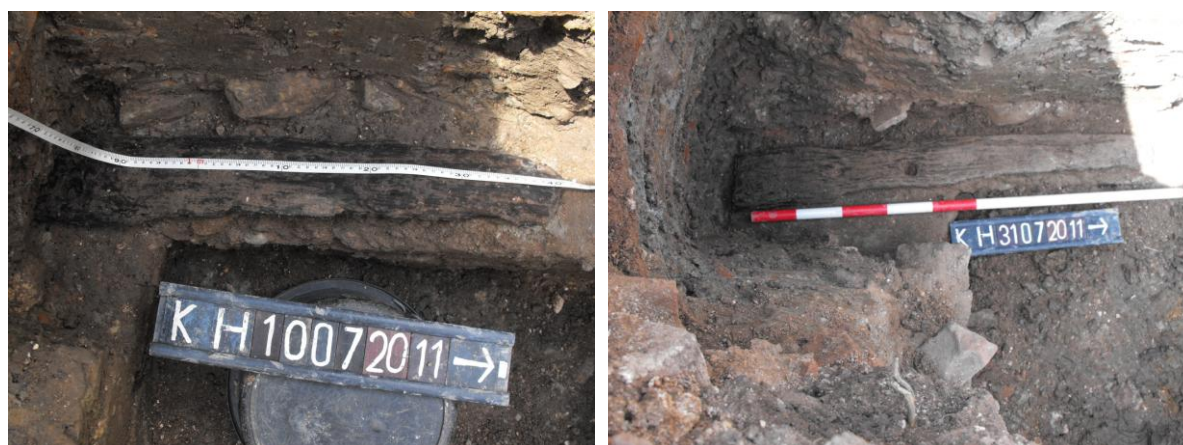
**Photo 19: Plank in situ**

The plank of wood (F500 - photo 19) preserved in a low waterlogged level at a depth of 1.66m below ground level has been identified from its dimensions and from the clear man-made square holes in it as probably forming part of the decorative framework for half-timbering of a house fascia. A trace of a diagonal plank overlaid on it was also identified (photo 20)

This is an important find for the whole site as it is the first evidence for a house with a half timbering feature. The wood was not suitable for dendrochronological assessment. However, a sample was submitted for carbon 14 dating. This resulted in two possible date ranges for the felling of the timber: either 1305-1365 or 1384-1431.

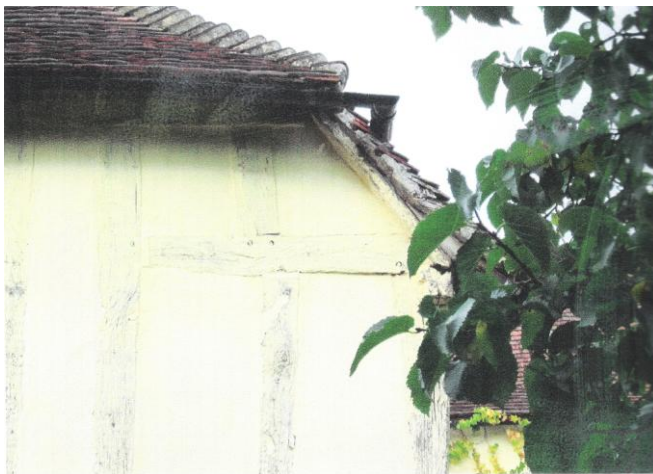
**Photo 21: Half-timbering at Paycocke's**

A similar piece of wood has been found on an extant building (Paycocke's, Coggleshall, Essex) (photo 21)
